## Building Envelope Performance

### 5.1 Doors

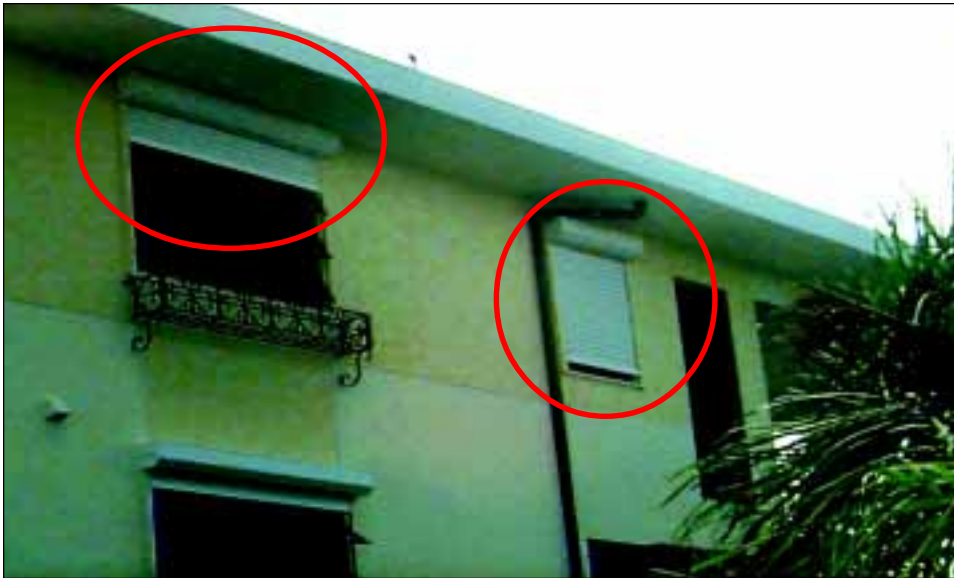
**FIGURE 5-37** These windows were equipped with roll-up shutters.

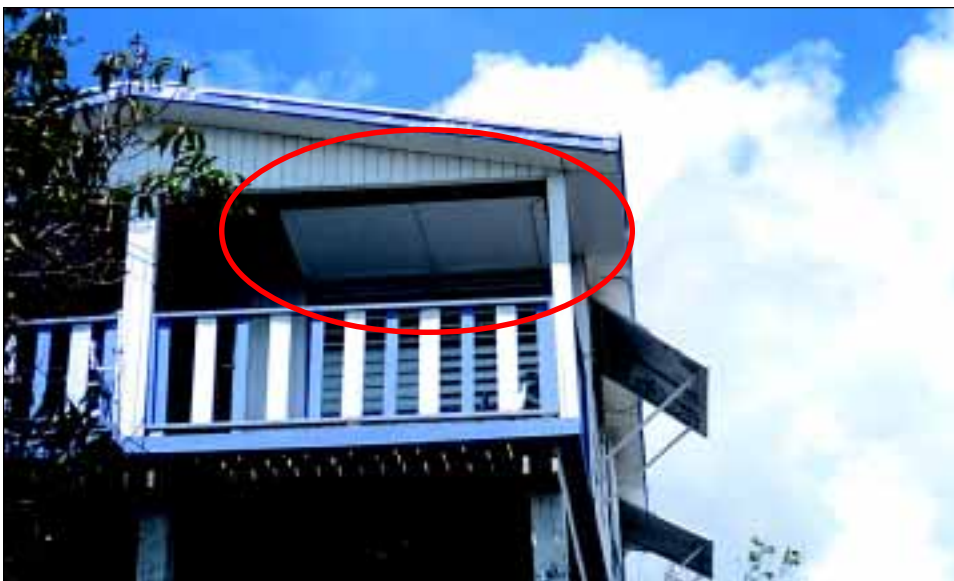
**FIGURE 5-38** This house had hinged plywood shutters. The front shutter protects a Miami window.

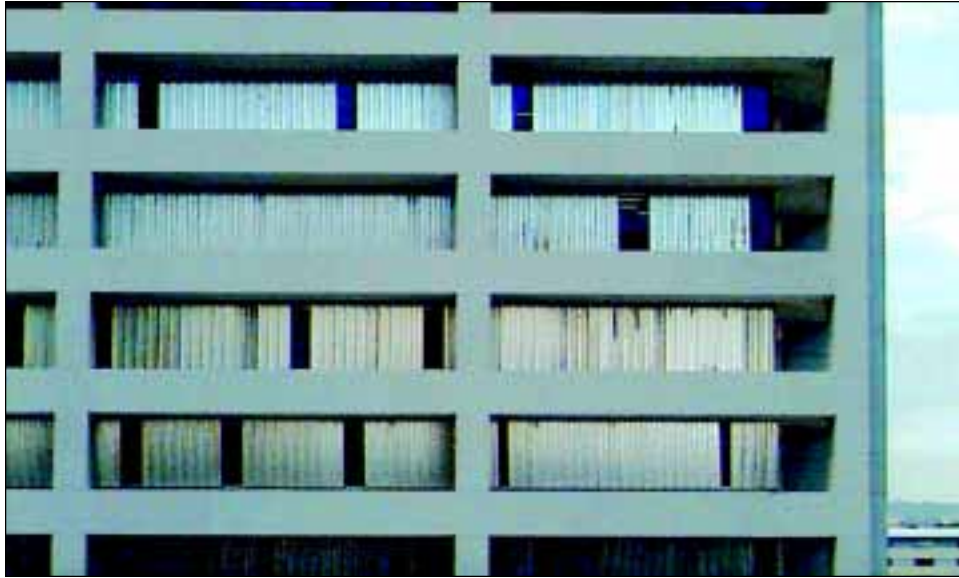
**FIGURE 5-39** Steel shutters were used on this mid-rise building, which had a narrow balcony in front of the windows. Since wind speed increases with building height, the shutters on the upper floors can receive very high wind loads. The length of the shutters on this building requires the shutter panels and their connection to the tracks to be strong enough to resist being blown out of the track. The shutter panels also must be stiff enough to prevent deformation against the glass, or they must be set far enough away from the glass so they do not press against it.

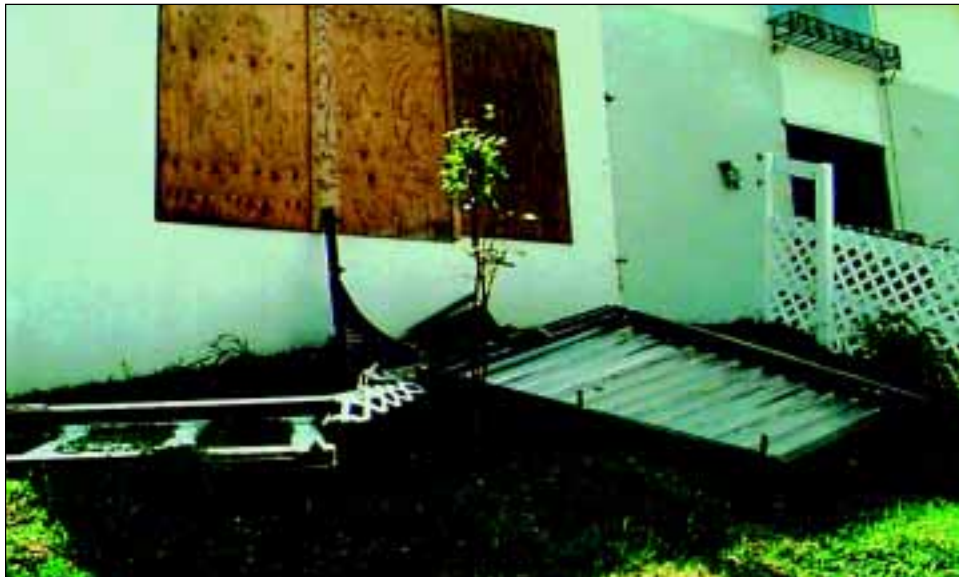
**FIGURE 5-40** The window lying on the ground was protected by a shutter. However, the shutter was attached to the window frame. The window frame fasteners were over-stressed and the entire assembly failed. Attachment of the shutter directly to the wall framing is a more reliable method of attachment.

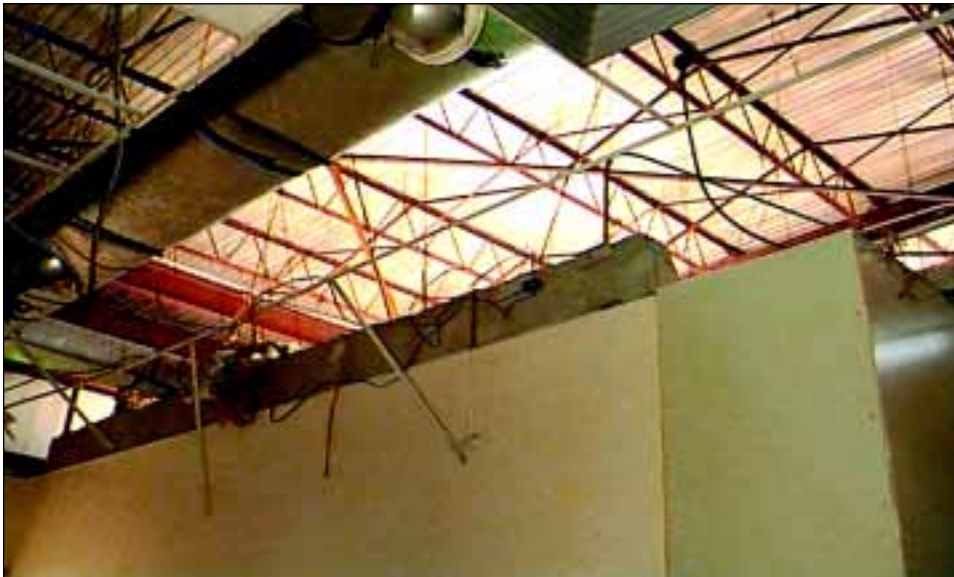
The BPAT noted the lack of compression struts, diagonal ties, and perimeter suspension wires in several buildings with acoustical ceilings (Figure 5-41). A lack of bracing was observed on some interior gypsum board/stud partitions as well as inadequate reinforcement and bracing of interior non-load bearing CMU walls (Figure 5-42).

**FIGURE 5-41** Part of the exterior envelope of this building blew away, resulting in damage to the acoustical ceiling. This revealed a lack of seismic resistance of the ceiling system, light fixtures, and ductwork.

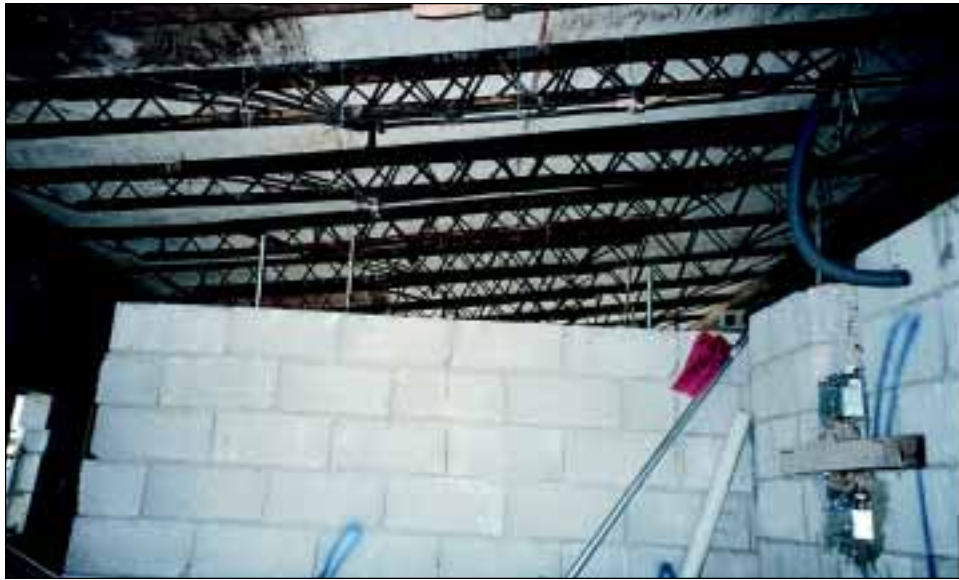
**FIGURE 5-42** An interior view of a house under construction (the steel joists are supporting formwork for the concrete slab). The CMU partition is inadequately reinforced and is not supported or laterally braced at the top of the wall.
